# CASE STUDY

## Former ATS Depot, Caernarfon Commercial high risk removal contract

Client:  
Marshall  
Construction

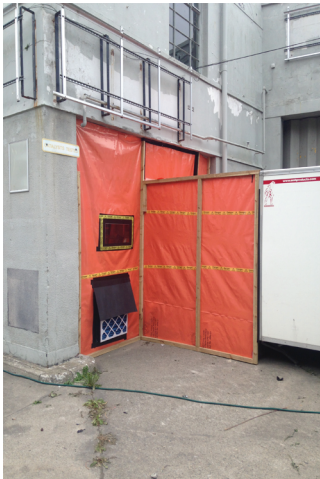
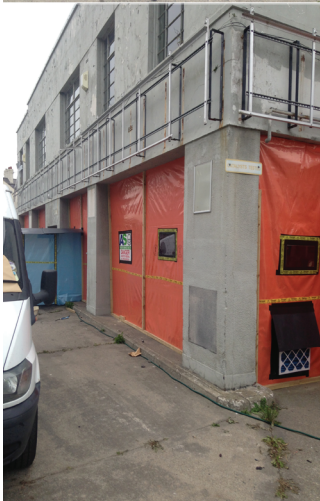
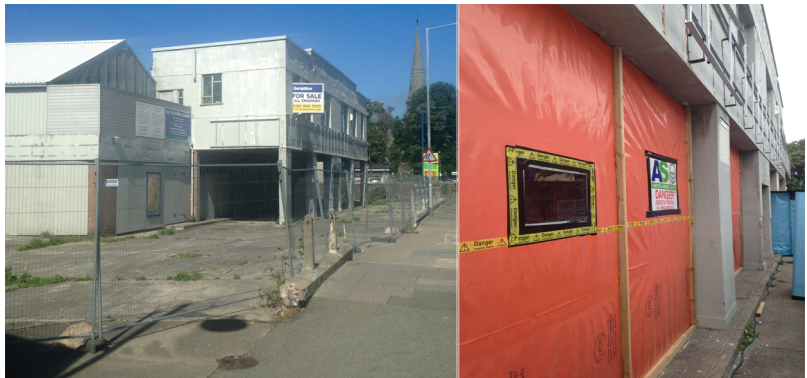
**High risk asbestos insulation board was found in a former ATS depot that required immediate removal prior to next occupation.**

The high risk removal works were programmed with an external enclosure to be erected to the underside canopy areas. A full enclosure was set up externally and direct DCU connection fixed to the enclosure. Site fencing was erected as a barrier around the enclosure to warn third parties of the ongoing works.

Once all asbestos insulation board was carefully removed, a full decontaminate clean of the enclosure area was carried out. All low risk materials including textured coatings and vinyl floor tiles were removed throughout the internal of the building prior to UKAS analyst attending on completion. The inspector confirmed all areas were safe prior to handing the area back to the demolition contractor.
